## Case 392 : Narrative

Case Vehicle (A): 2002 Dodge	Vehicle (B): 1999 Chevrolet
Type: Stratus ES, 4-door sedan	Type: Metro, 2-door Hatchback
Driver: 76-year-old female	Driver: 20-year-old male
CDC: 11-FLEW-1	CDC: 01-FDEW-3

CASE NO.: 392-03

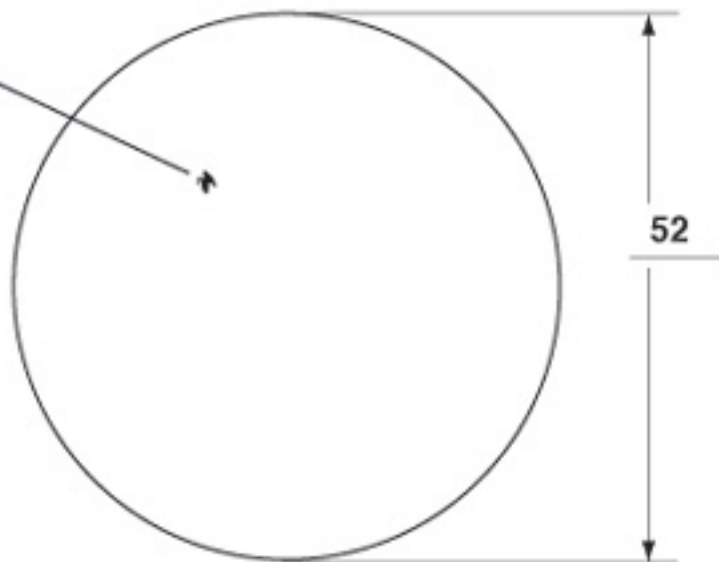
Driver Airbag

Makeup or  
fluid stain

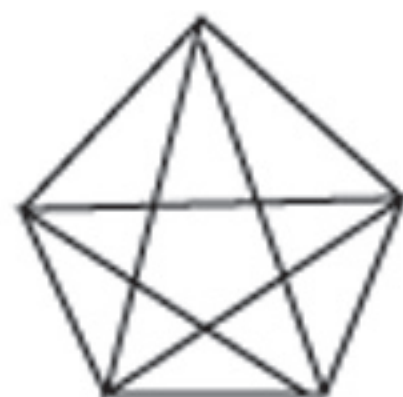
WINDSHIELD MARK ON CASE VEHICLE:

**Windshield cracked in lower left corner by rear edge of hood  
and on right side due to contact by  
dash-mounted airbag cover**

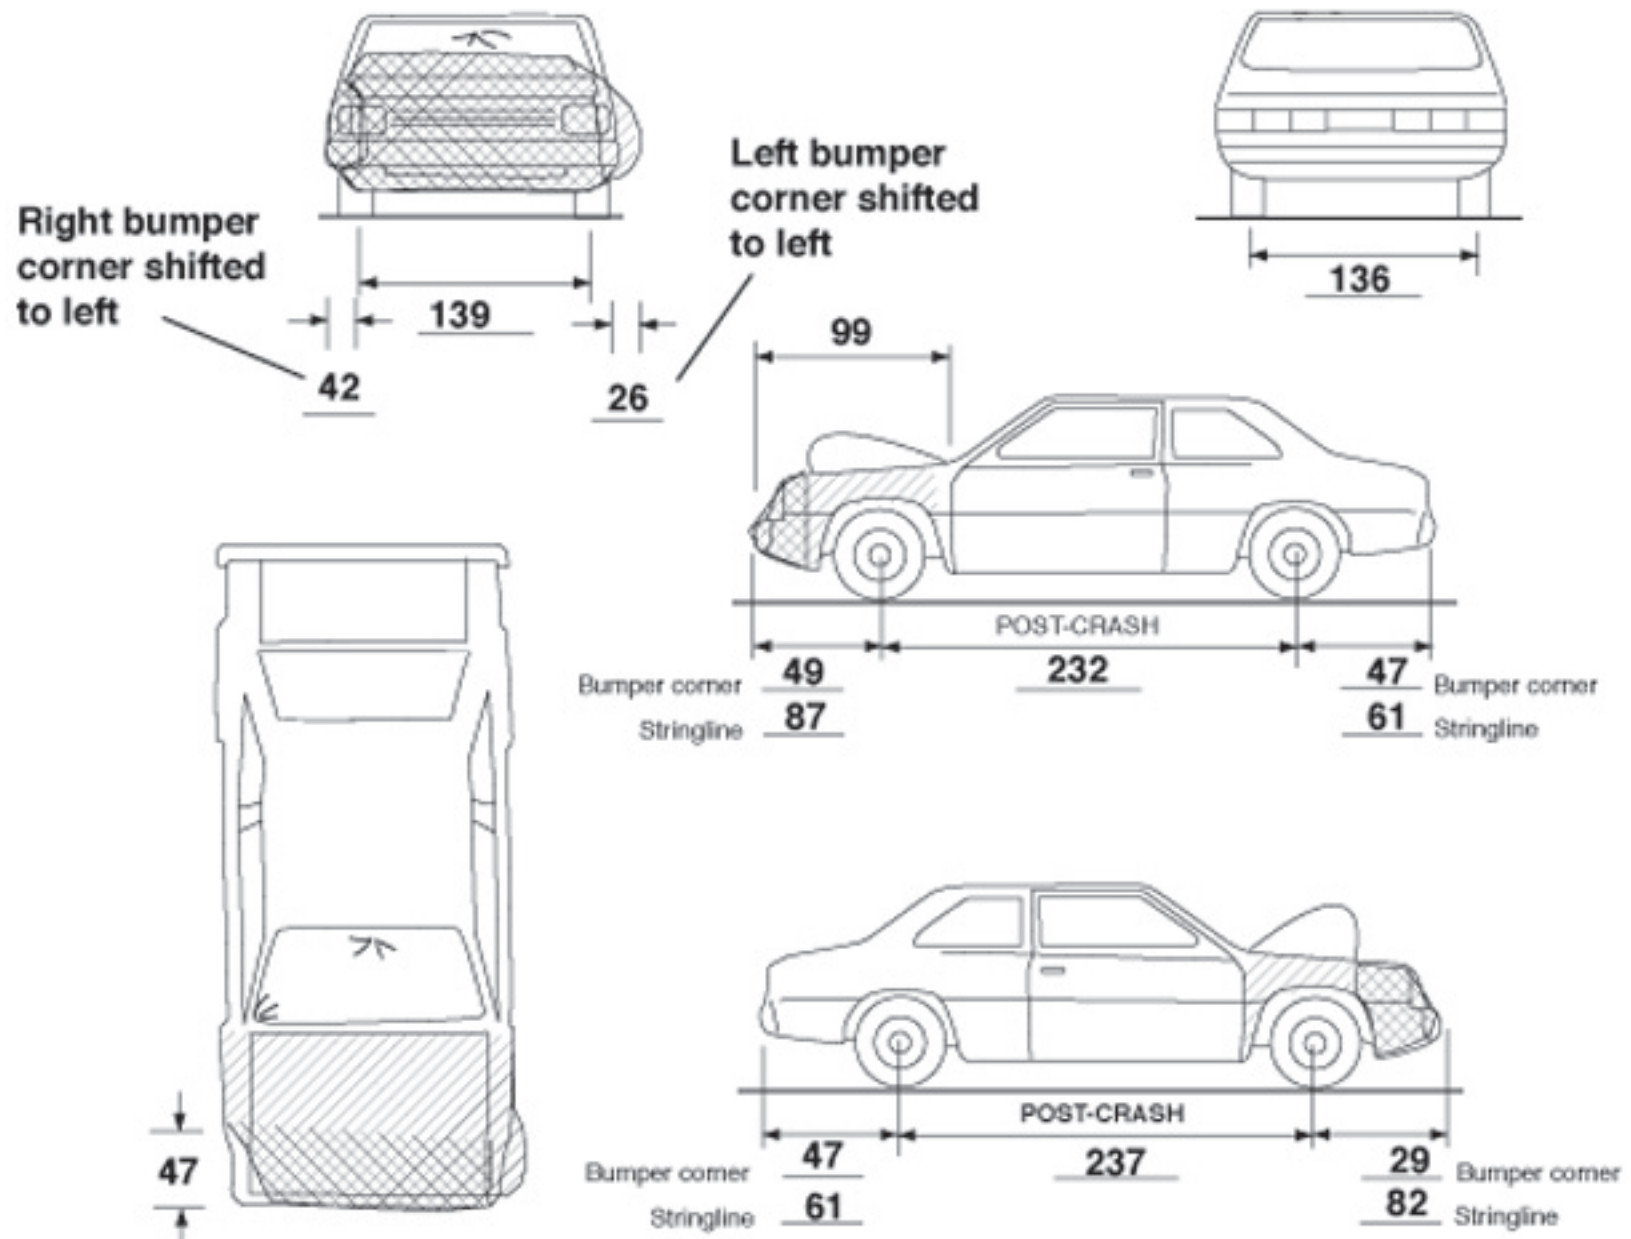
Width of direct damage  
to front
